No. 221250J

# Test Report

TYPE: U70B146/320N16W

DESIGNATION: Suspension Ceramic Insulator

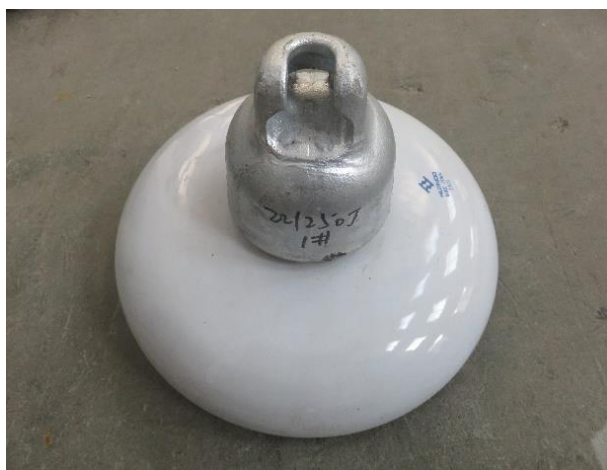
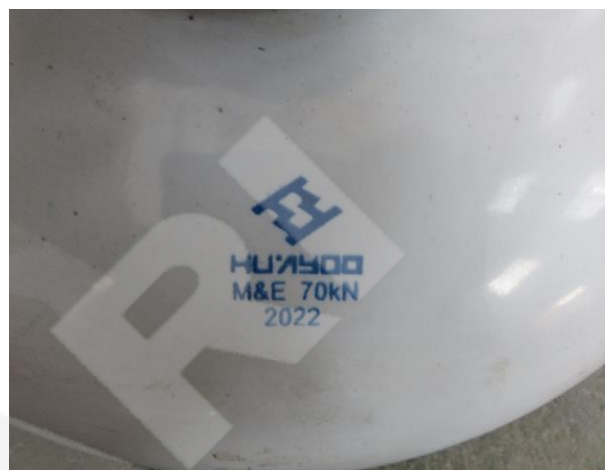
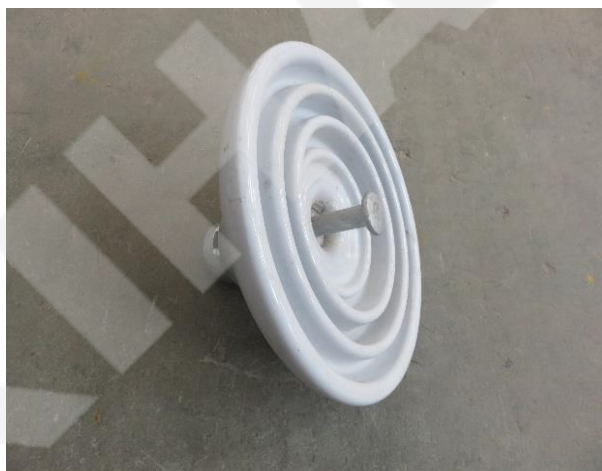
Photograph 1

Specimens No.1 ~ No.80 had fair appearance. The ceramic were labelled "70kN". No defects exceeding standard permission were observed, met the test basis satisfactory. The result met test standard and the technical specifications.

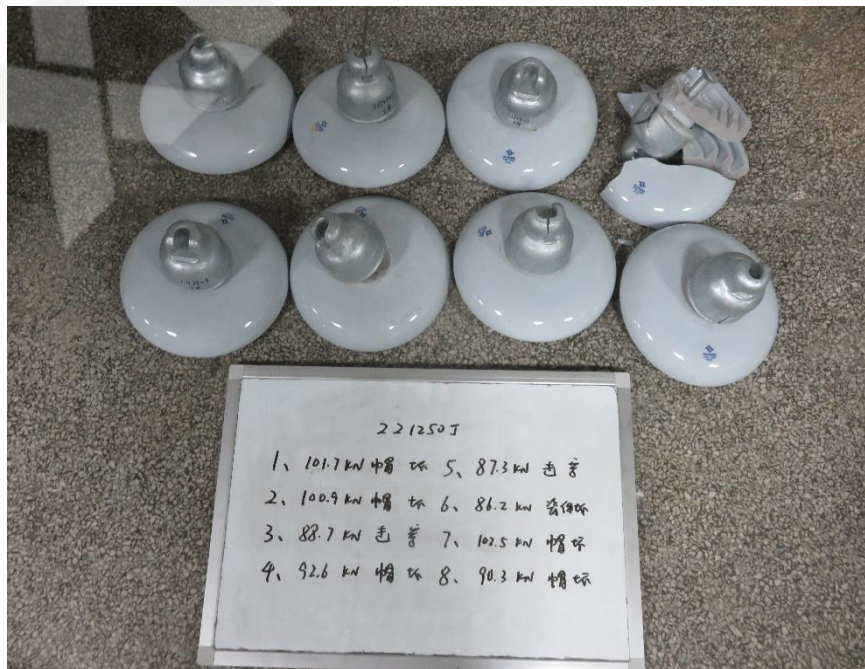
Photograph 1

The tensile load was applied between cap and pin in line with the axis of the specimen. The load was started at zero smoothly brought up to the failing point. Simultaneously, a power frequency voltage of 36kV was applied to the test specimen.

The result met test standard and the technical specifications.

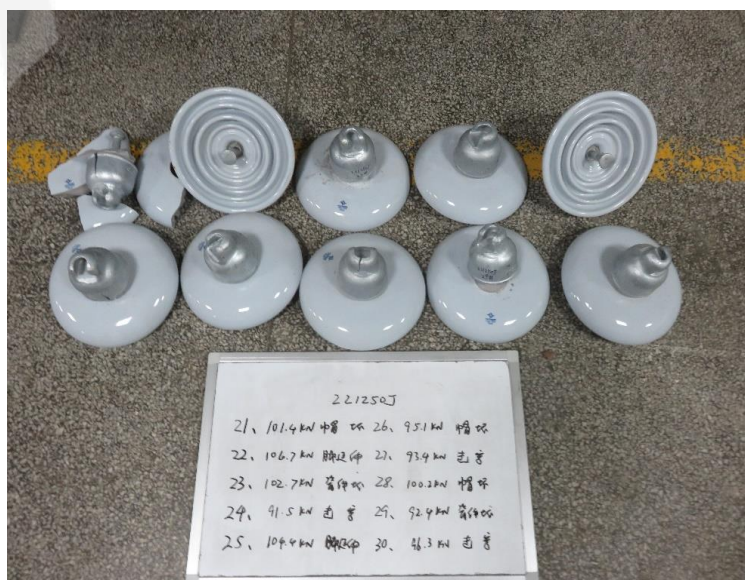
Photograph 1

The tensile load was applied between cap and pin in line with the axis of the specimen. The load was started at zero smoothly brought up to the failing point. Simultaneously, a power frequency voltage of 36kV was applied to the test specimen.

The result met test standard and the technical specifications.

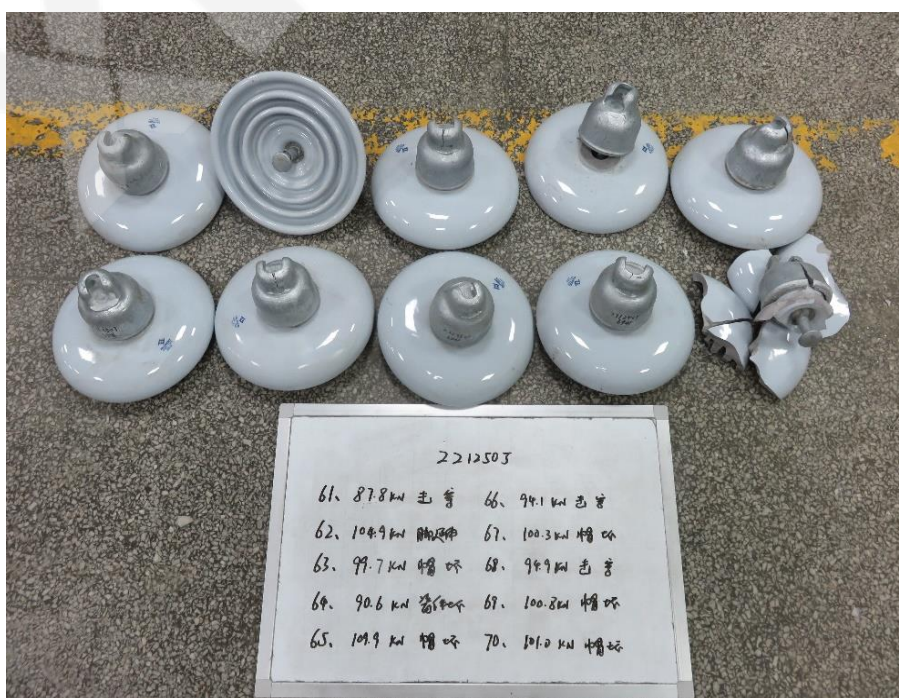
Photograph 1

The tensile load were applied between cap and pin in line with the axis of the specimen. The load was started at zero smoothly brought up to the failing point. Simultaneously, a power frequency voltage of 36kV was applied to the test specimen.

The result met test standard and the technical specifications.
